VILLAGE OF MONTROSE

2015 ANNUAL REPORT OF WATER MONITORING

August 2016

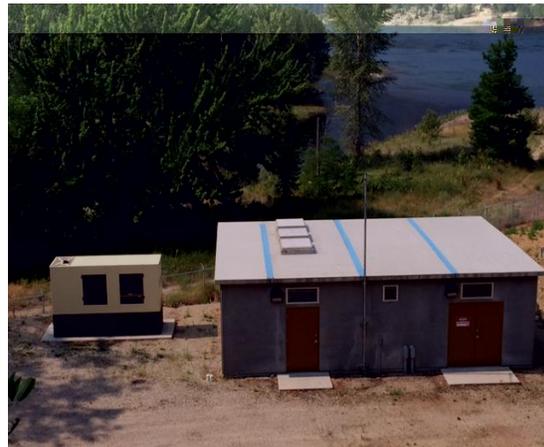
Chlorine is injected at the Water Treatment Plant at a rate of 0.75 – 1.0 mg/l with the majority of the distribution system seeing concentrations of 0.5 – 0.7mg/l. The injection rates fluctuate during the year with the minimum requirement of 0.2 mg/l residual at distribution system extremities used as a control. There are many challenges in maintaining these limits and dead-end main lines, dual pressure zones, water use and temperatures all affect the required chlorine residual.

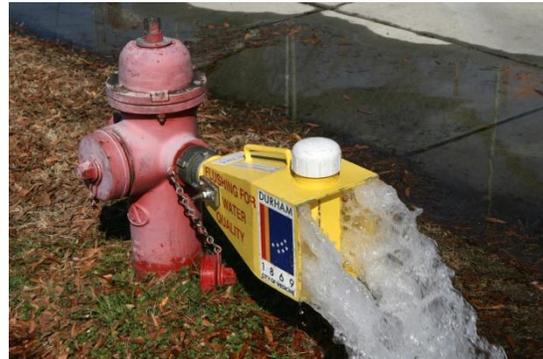
In 2011, TRUE Consulting was engaged to provide the Village with a formal unidirectional flushing (UDF) program for the annual flushing of watermains. The 2015 annual flushing program was completed in the spring and fall. The Village also maintains hydrants within the Village where the mains are also exposed to flushing activities.

Hydrants are inspected yearly to determine the Village and to provide adequate fire protection. Village staff performs inspections such as checking the hydrant pressure, exposing any worn parts, and updating service records. In 2009, the Village began a program to include capital funding to allow for any required replacement of older fire hydrants.
