## **VILLAGE OF MONTROSE**

### **2015 ANNUAL REPORT OF WATER MONITORING**

**August 2016**

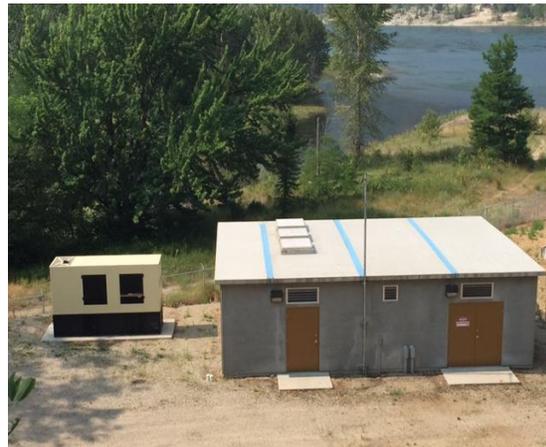
Chlorine is injected at the Water Treatment Plant at a rate of 0.75 – 1.0 mg/l with the majority of the distribution system seeing concentrations of 0.5 – 0.7mg/l. The injection rates fluctuate during the year with the minimum requirement of 0.2 mg/l residual at distribution system extremities used as a control. There are many challenges in maintaining these limits and dead-end main lines, dual pressure zones, water use and temperatures all affect the required chlorine residual.

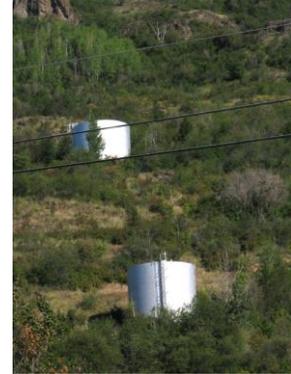
Reservoir #1 (lower) was constructed in 1959. It is an elevated steel-finished tank consisting of one cell and has a storage capacity of 455m<sup>3</sup>. Its full water level elevation is approximately 637 metres.

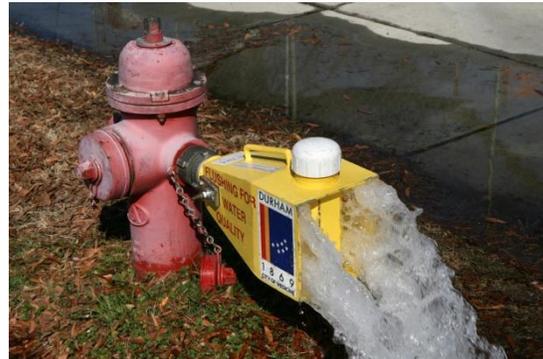
Hydrants are inspected yearly to determine the unit's ability to function properly, and to provide adequate fire protection. Village staff performs inspections such as checking the hydrant pressure, exposing any worn parts, and updating service records. In 2009, the Village began a program to include capital funding to allow for any required replacement of older fire hydrants.
